Preliminary
State Emergency Assessment Team
DRAFT
Report Gap Fire
Santa Barbara County
October 9 2008

GAP FIRE COMPLEX SEAT TEAM REPORT

Executive Summary

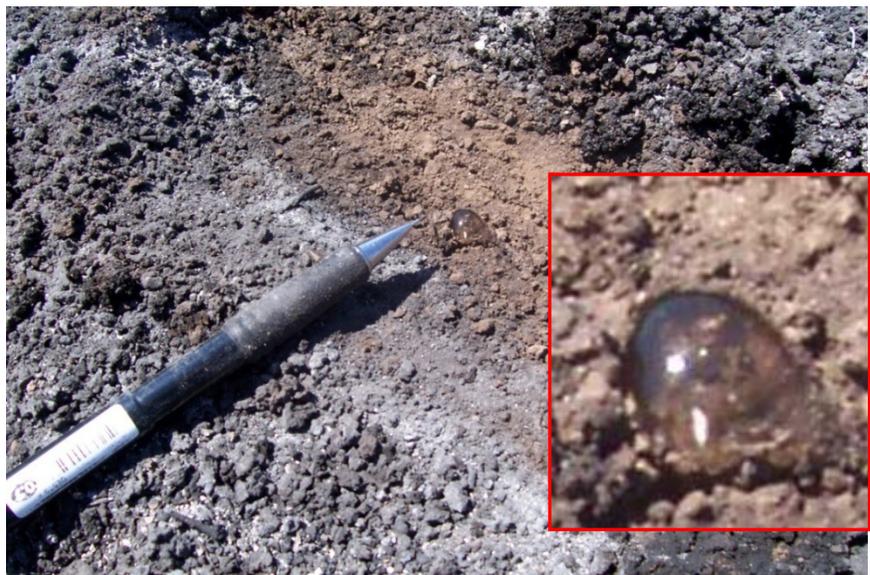
Pen points to a drop of water on hydrophobic soils that never soaked in for more than 20 minutes during the site visit to a moderately burned site.

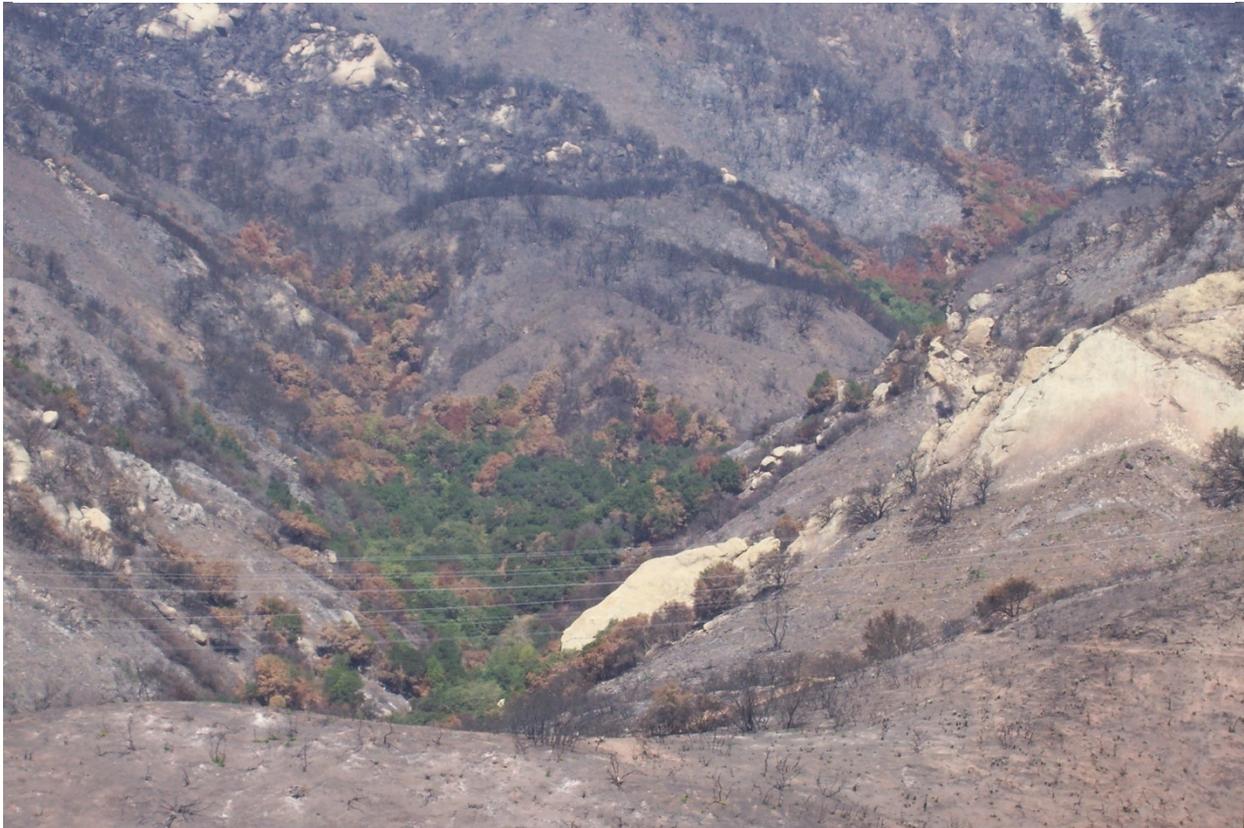
Gap Fire area of minimal groundcover and existing unstable slopes

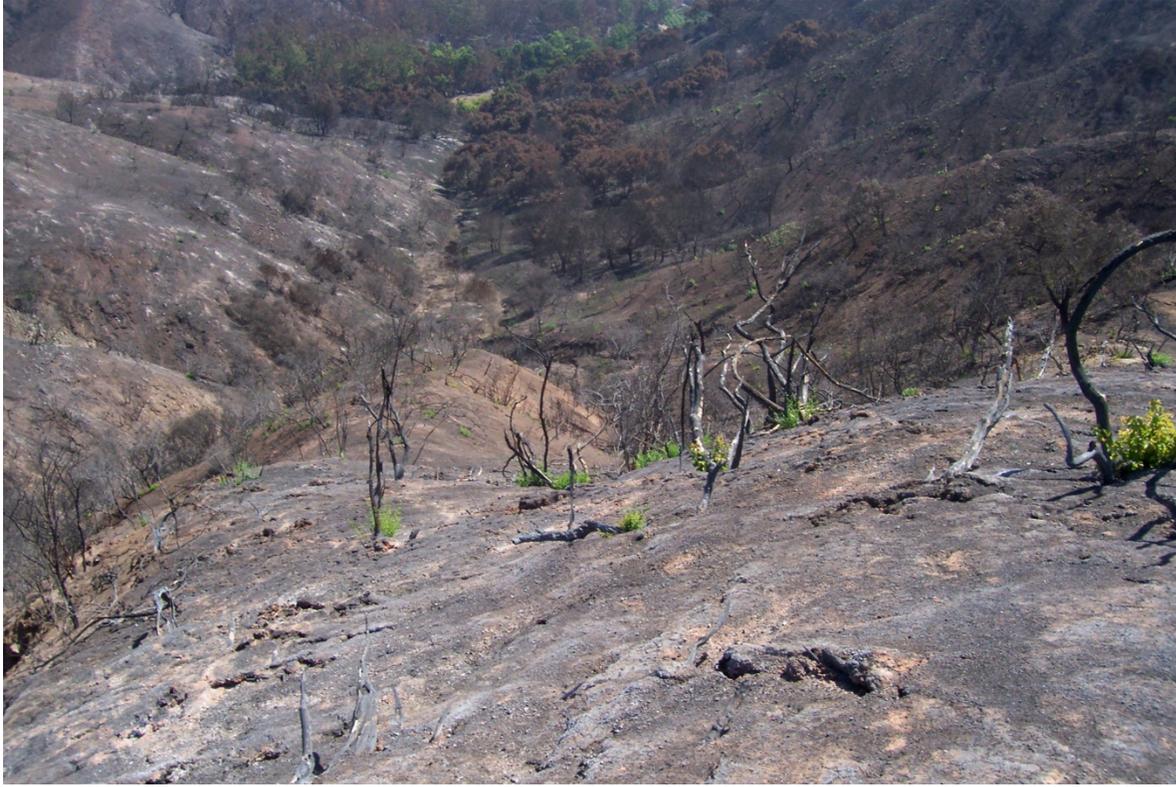
Valley bottom below steep unstable slopes capable of sediment storage as seen by the existing natural storage at the top right of the picture; it may be possible to use Loose Rock Check Dams or temporary silt trapping structures in areas such as this. These wide areas are naturally drained by low gradient, small Class III Type streams (CalFire). Proper design to fit the site and monitoring after all storms is critical for success with any structure used for this purpose.

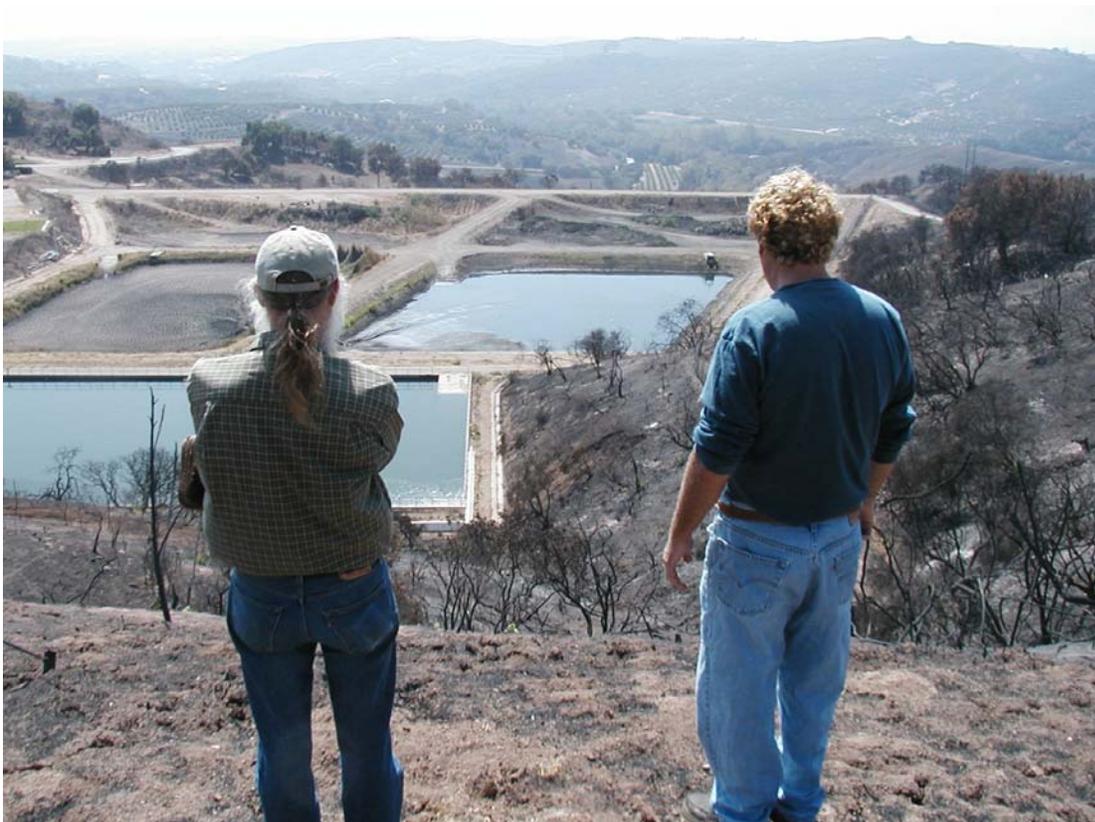
One example of resources at risk is the site of the Corona Del Mar Water (CDMW) treatment plant in the Upper Glen Annie Canyon watershed. This facility supplies water for the City of Goleta and while the facility itself is on stable ground, it is surrounded by slopes that were burned and are now more at risk of slope instability. SEAT members contacted staff at the facility and discussed slope stability concerns with them. SEAT Team suggested irrigation of soils prior to rains to stimulate seed sprouting and natural breakdown of hydrophobic soils. CDMW staff were aware of the slope stability problems and other problems associated with the fire. They have installed K-Rails at the most vulnerable ponds but additional work should be initiated to further protect the most threatened. The water delivery lines appear to be especially susceptible to damage from debris flows and unstable fills and slope movements that can occur for several winters.

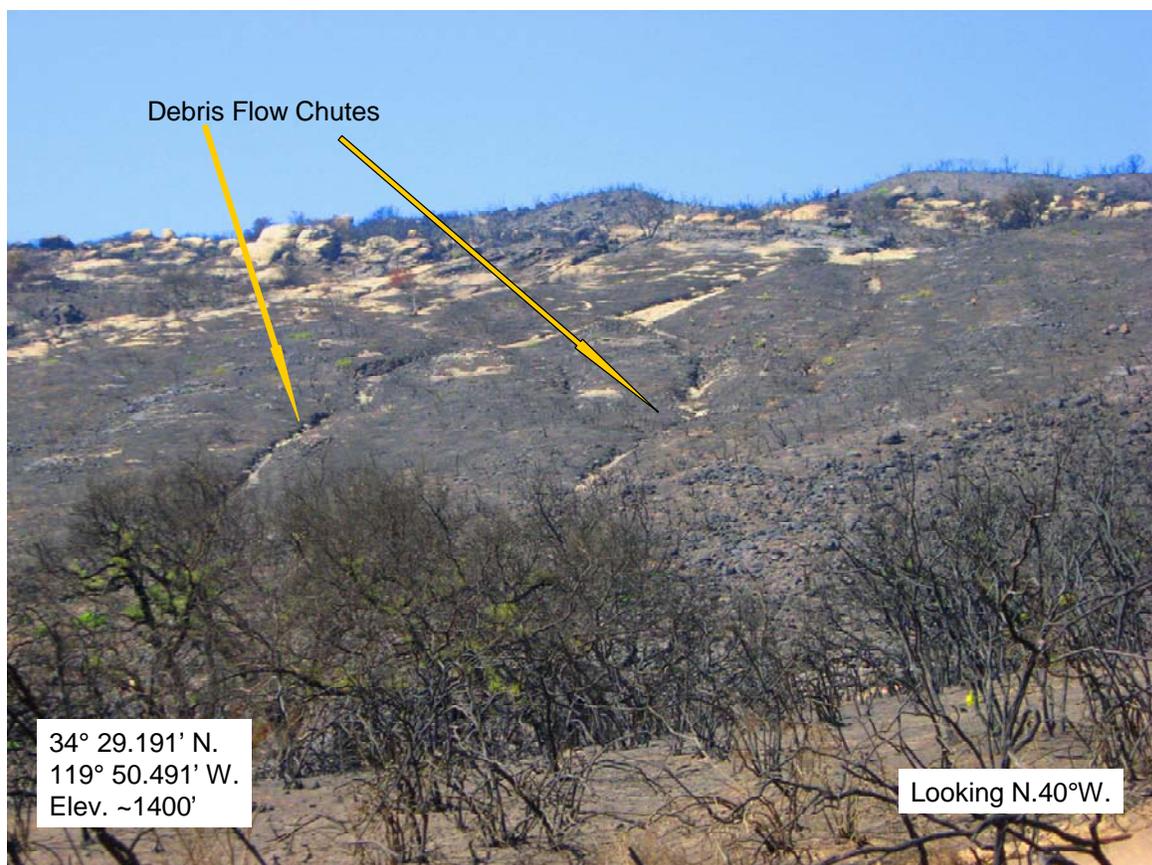
Figure 1. Example of existing and developing debris flow chutes and channels. Moderate to high burn severity occurred in this area. Bottoms of incised channels contain cobble and boulder-sized clasts.

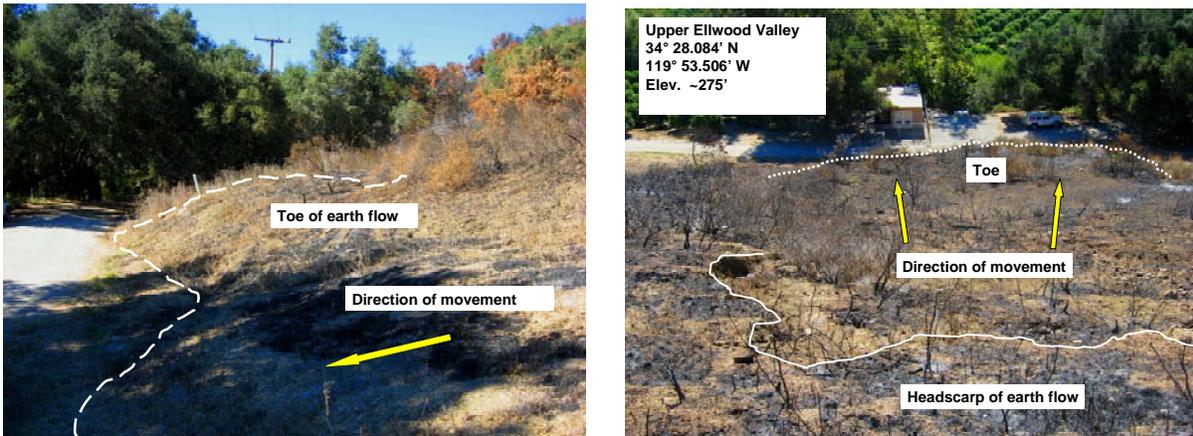
Figure 3. Example of an existing advancing earth flow found within the burn area. Burn severity within the slide mass is moderate. The building is a public water conveyance structure located next to Ellwood creek. The creek bottom contains rounded boulders 2-feet to 6-feet in diameter. The boulders were deposited during high flooding and prior debris flow events.

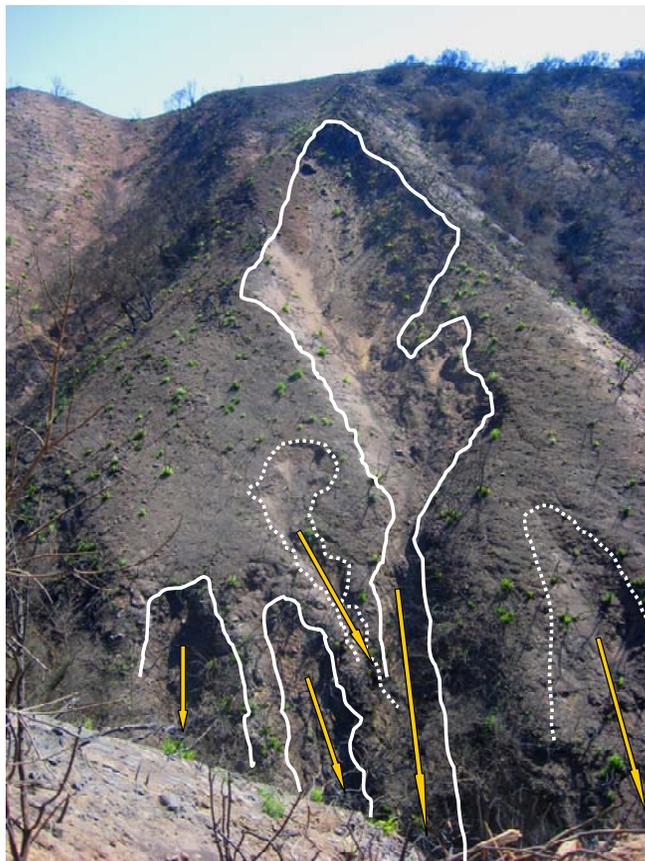
Figure 2. Example of inner gorge rock falls, debris chutes, raveling slopes, and landslides. Similar geology exists at similar elevations throughout the burn area.

Steep Inner Gorge
 Multiple active landslides
 Moderate to High Burn Severity
 Development of active rockfall chutes
 Headscarps advancing upslope
 34° 28.020' N.
 119° 53.341' W.
 Elev. ~760'

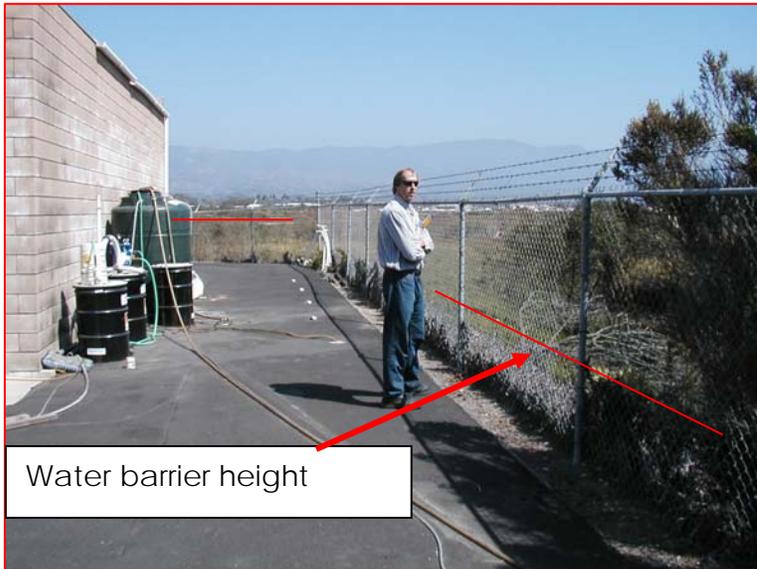
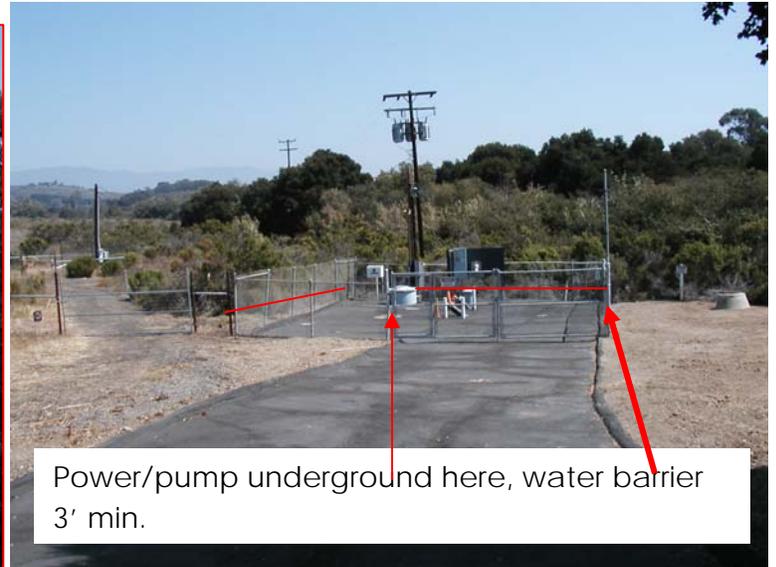
West Goleta Pumping- Pump station by airport. SEAT Team Suggested

“Water Barriers” at this site and primarily “Emily” pumping station due to power location.

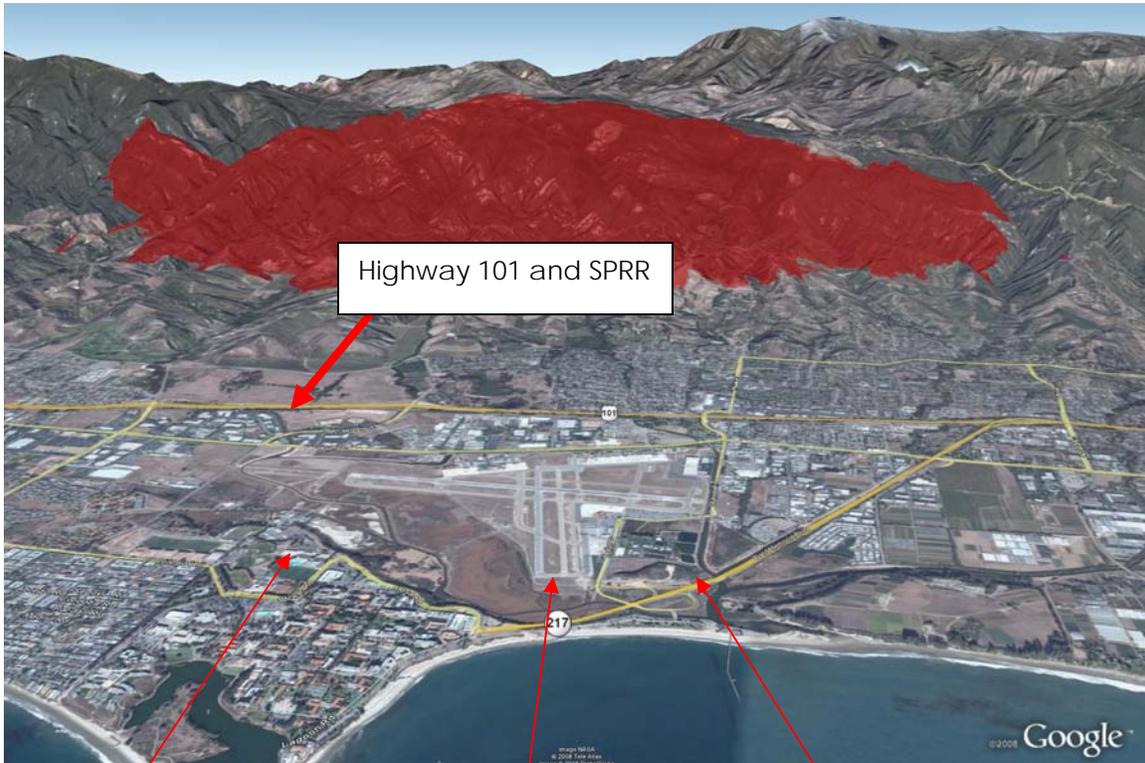
West Goleta Pumping Station Santa Barbara Airport and Goleta Sewer Plant

Goleta Sewer District- Fairly high above floodplain Ponds are on the San Pedro Creek. Staff Reviewed plant design, emergency preparedness and flood history with Jeff Salt the Operations Manager

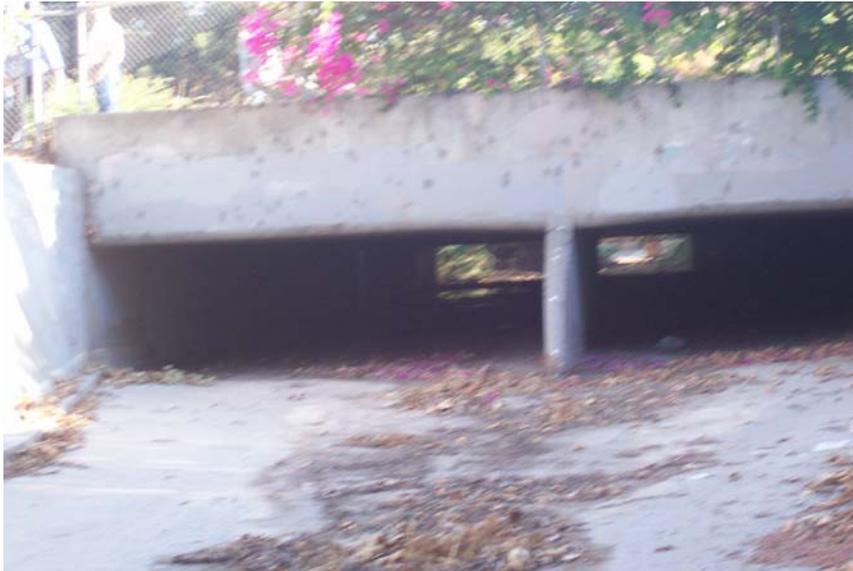
Union Pacific Railroad- Same elevation as the Highway with limited drainage capacity.

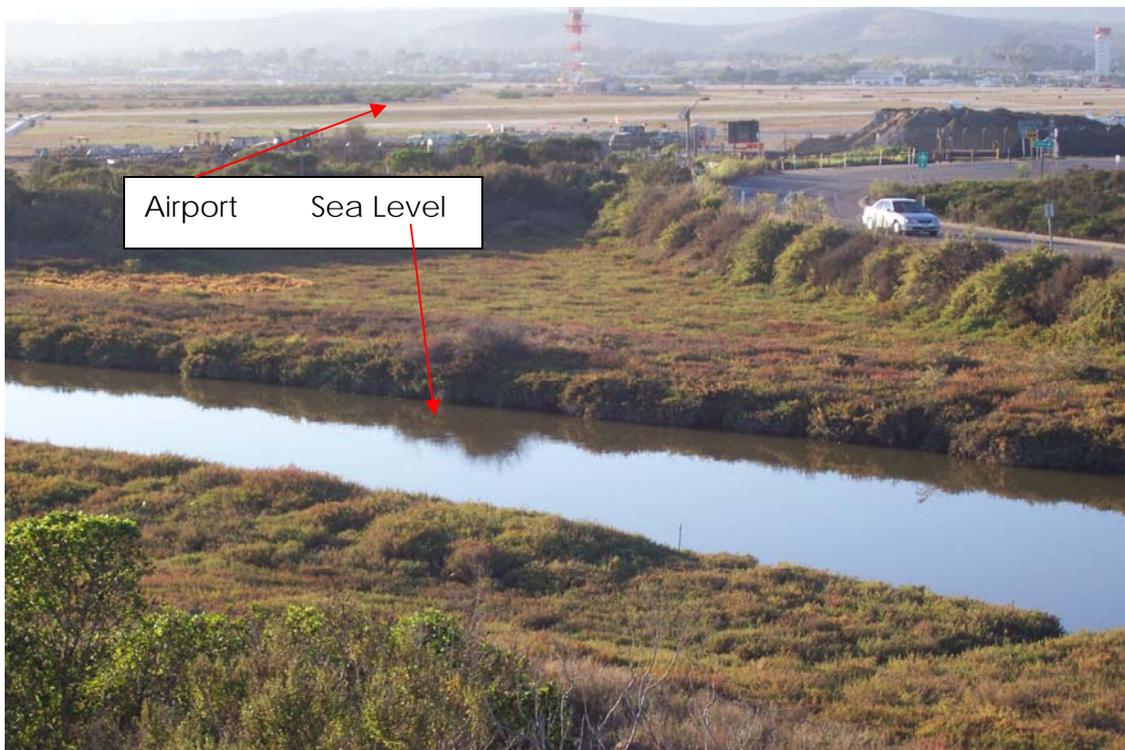
Santa Barbara City Airport- This facility is based at lower end of 4 drainages that were severely burned. The airport was flooded in 1995 and 1998 poor drainage due to location in proximity to the ocean tidal influence (sea level) and the in the floodplain of several creeks that were diverted around the airport to create the runways.

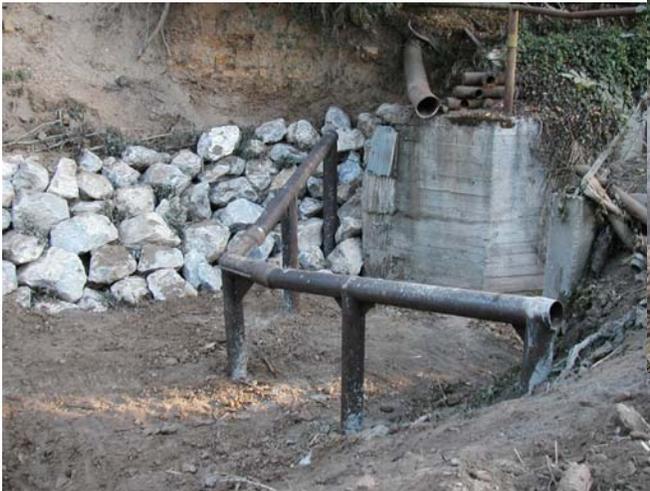
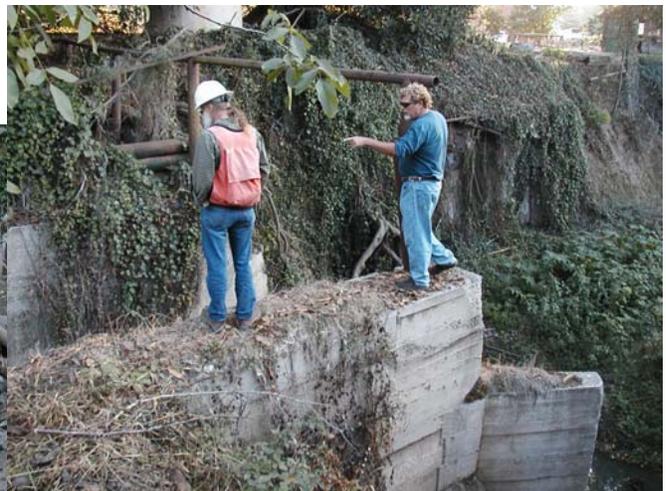
1.Trash Rack completed on Ellwood Creek upstream of Langlo Ranch Road

This project should be evaluated by and Licensed Civil Engineer who is familiar with Protection of Drainage structures. Wingwall fills on both sides of this structure are narrow and have been eroded by uncontrolled runoff off both the orchard and a abandoned road crossing on the south side of the structure. When large storms carry sufficient debris to the trash rack flows will be elevated and erosion of both the bank above the existing rip-rap and two wingwall fills on both sides will be subjected to elevated flood flow erosion. These flows and discharge off of the road on the south side of this concrete structure have a increased potential to erode away all support for the structure and supporting hillslope for the access road. Addition of a geotextle fabric and additional rock armoring or other engineered slope protection that is sufficient to resist flood flow erosion is called for but a full review and remediation should be conducted as soon as possible, by a trained professional.
