Marek Fire

State Emergency Assessment Team (SEAT)
Report

Affected Watersheds in Los Angeles County
California
October 30, 2008

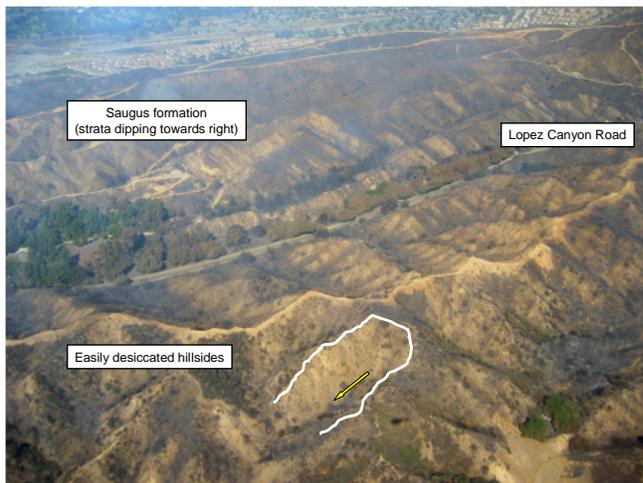
Being loosely consolidated and structurally tilted through faulting, the Saugus formation easily erodes. Dry raveling of sands appears common. Most of the erosion seen in the burn area appeared to be from general sloughing and incised channeling during rain events. The formation is easily disturbed by mechanical impact such as by tires. Deep-seated rotational earth slides were generally not seen in the burn area. A series of pictures of this formation are provided for review in Figures 4, 5, and 6. Figure 4 (below) of the Saugus formation.

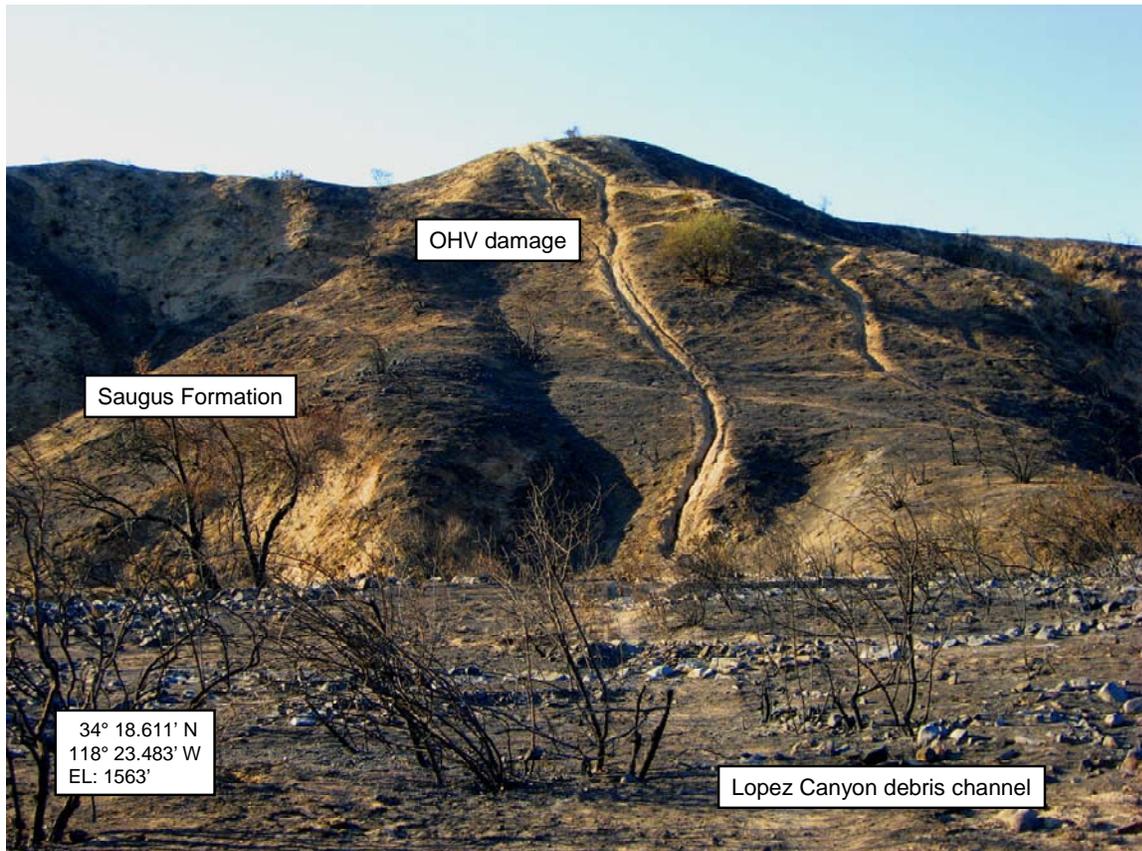
Figure 5: (Below) OHV damage of Saugus formation in the burn area.

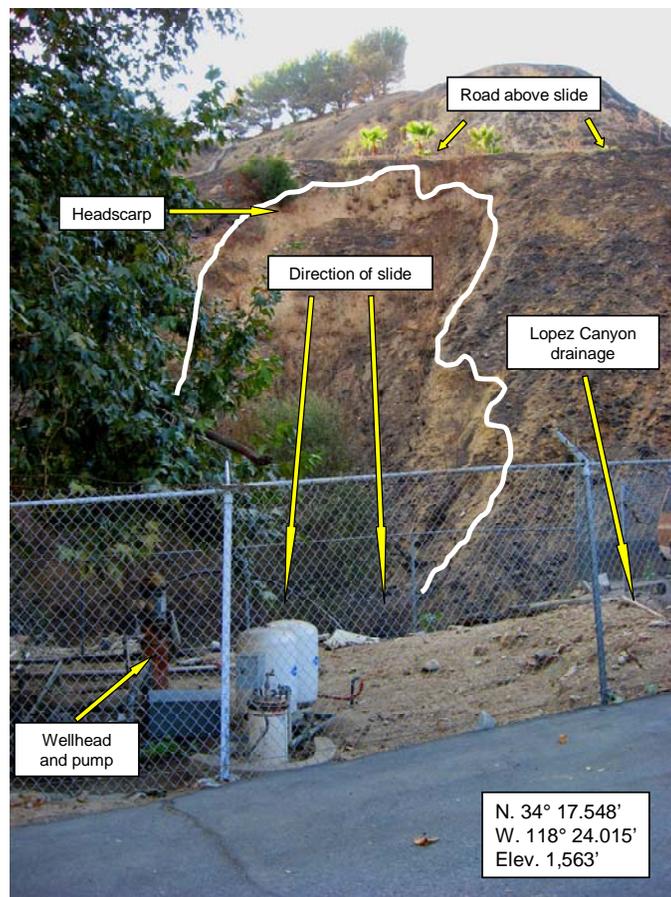
Figure 7: Earth slide toe is in Lopez Canyon creek drainage.

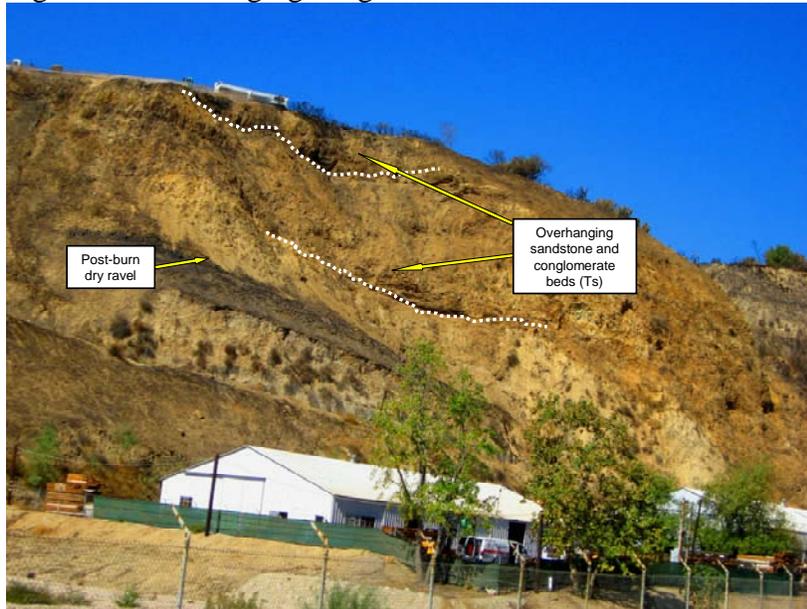
Figure 8: Overhanging conglomerate and sandstone beds above buildings.

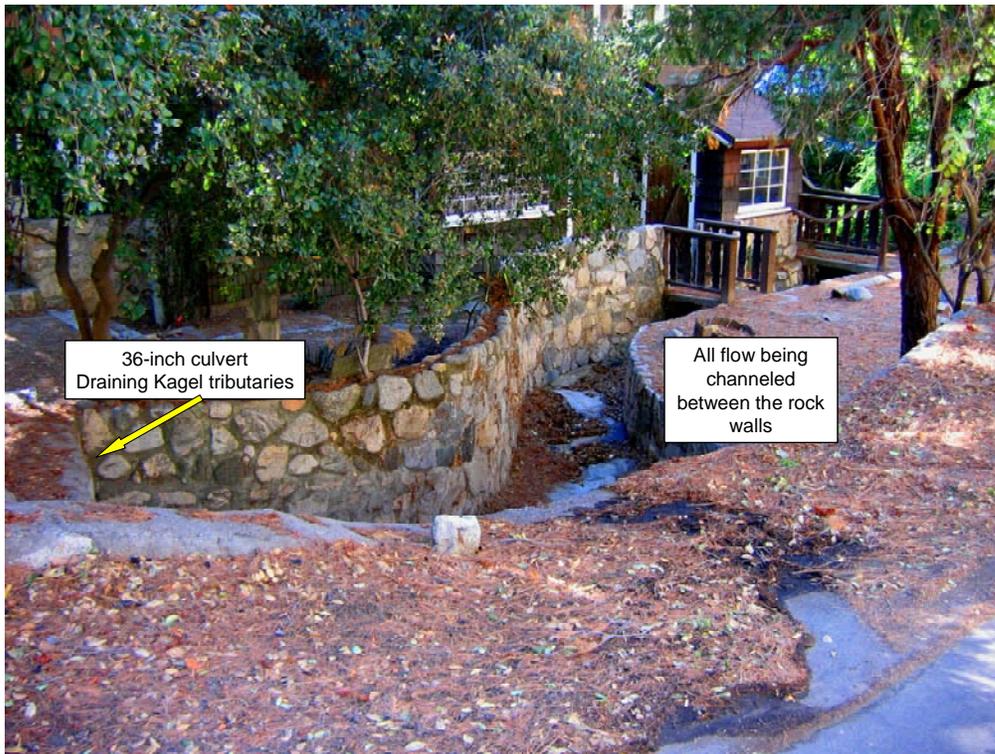
Figure 10:

Downstream from the park, numerous homes, residences, outbuildings, structures, roads, trails, infrastructure, and other properties exist within, adjacent to, or nearby the drainage channel. Homes, residences, outbuildings, structures, and other properties also exist within small, narrow, tight, steep, side canyons located adjacent to and upstream from the main drainage. Access and escape routes are very limited. Sudden and/or continued heavy storm events may limit movement both in and out of the area. Entrapment may occur. Figure 10 is an example of a home in extremely close proximity to the Kagel drainage.

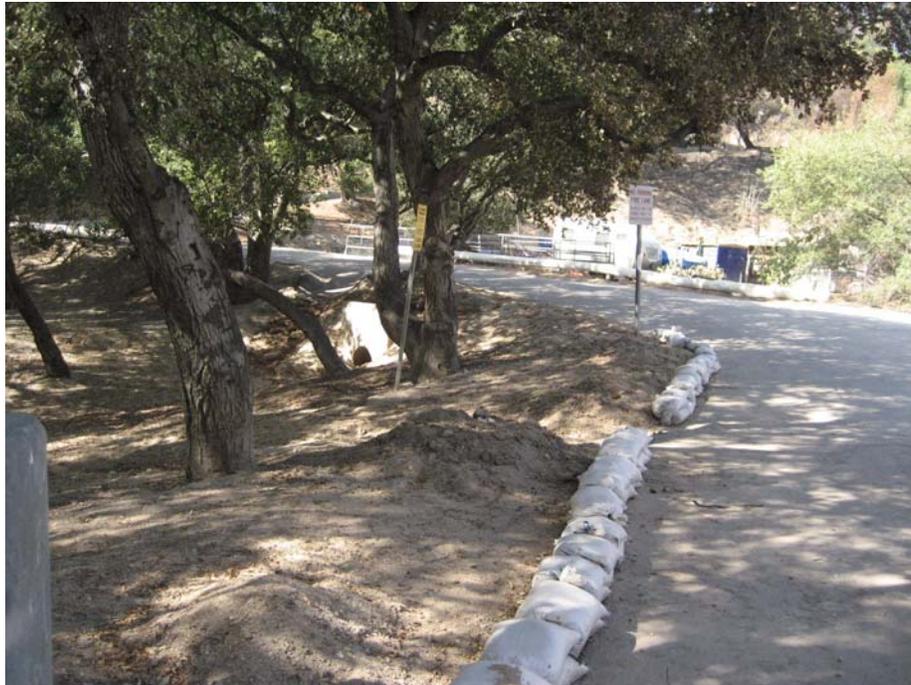
Map Pt. K-2—Dexter County Park. (Note sand bagging that has already begun to reduce potential flooding impacts in Kagel Canyon).

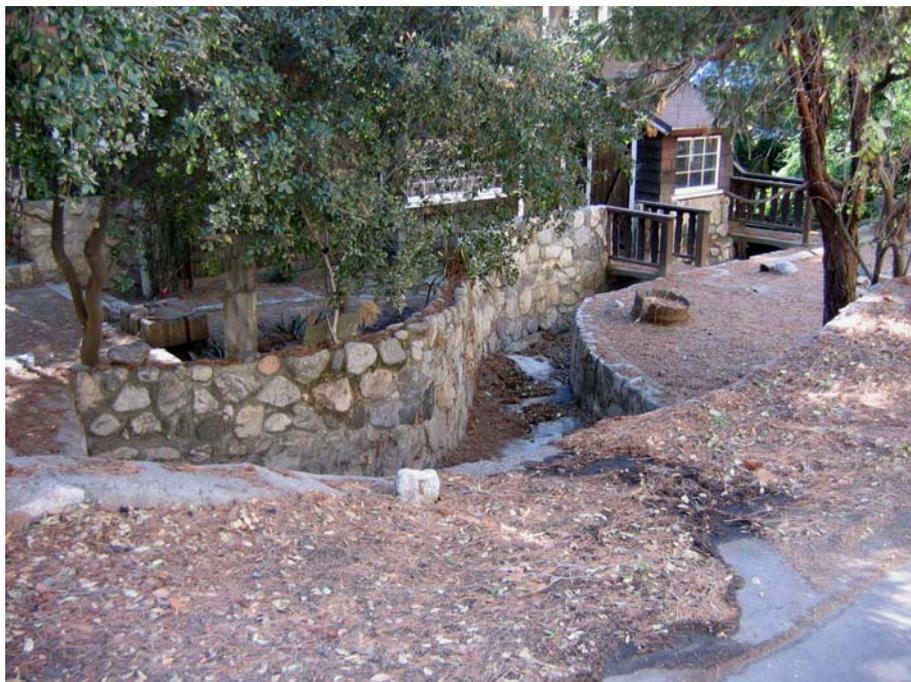
Map Pt. K-3—Residence at risk to flooding and debris below Dexter County Park in Kagel Canyon. (Note the stone lined channel for an unnamed tributary to Kagel Canyon routed immediately next to this residence).

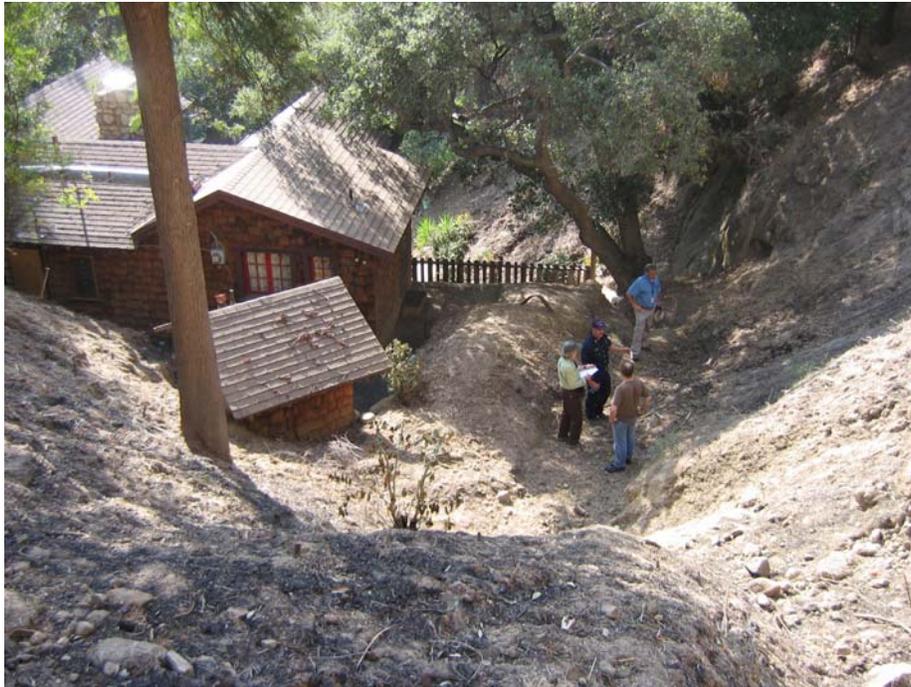
Map Pt. K-5—Residence denoted as high risk to flooding and debris flow damage in Kagel Canyon off of Spring Trail.

(Note: SEAT team discussing potential mitigation measures with the homeowner).

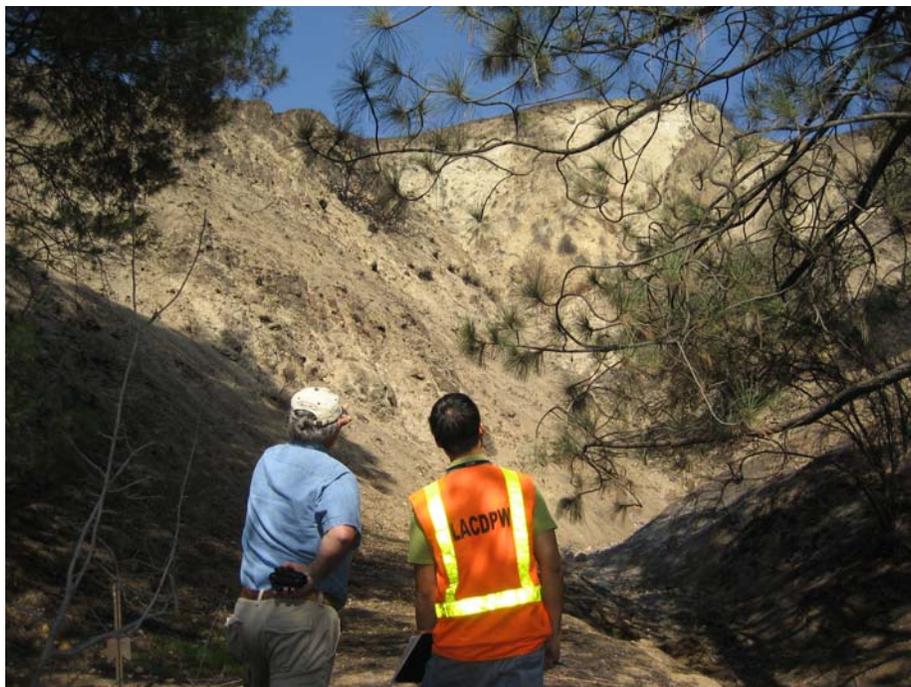
Map Pt. K-5—Small draw immediately above a residence denoted as high risk to flooding and debris slide damage in Kagel Canyon along Spring Trail.

(SEAT Geologist Darby Vickery, PG, discusses possible impacts with an LACDPW civil engineer).

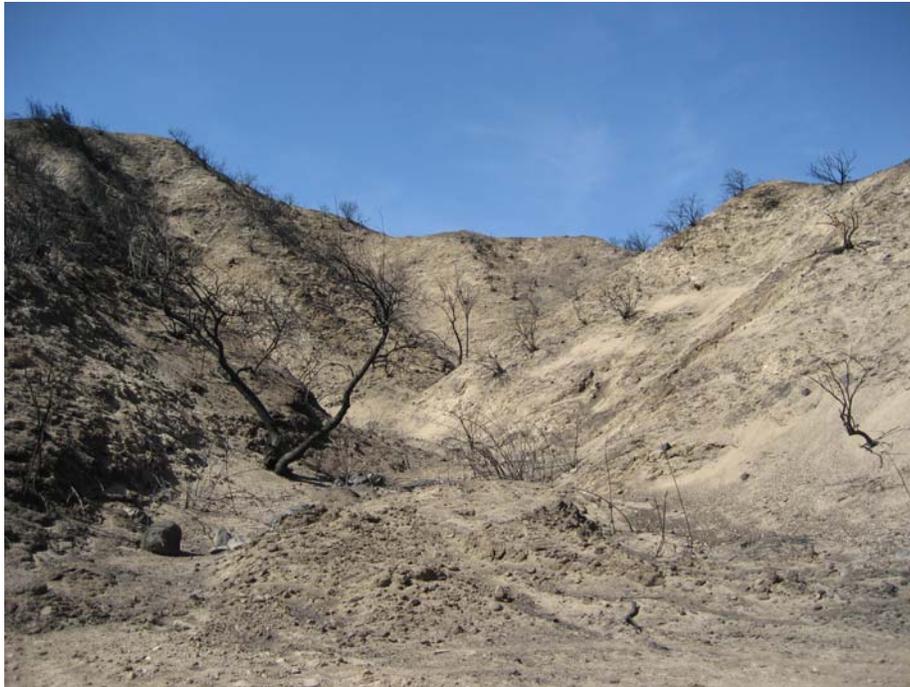
Map Pt. LOP-9. Burned/denuded 39 acre watershed that drains directly into the Hope Garden Family Center in lower Lopez Canyon.

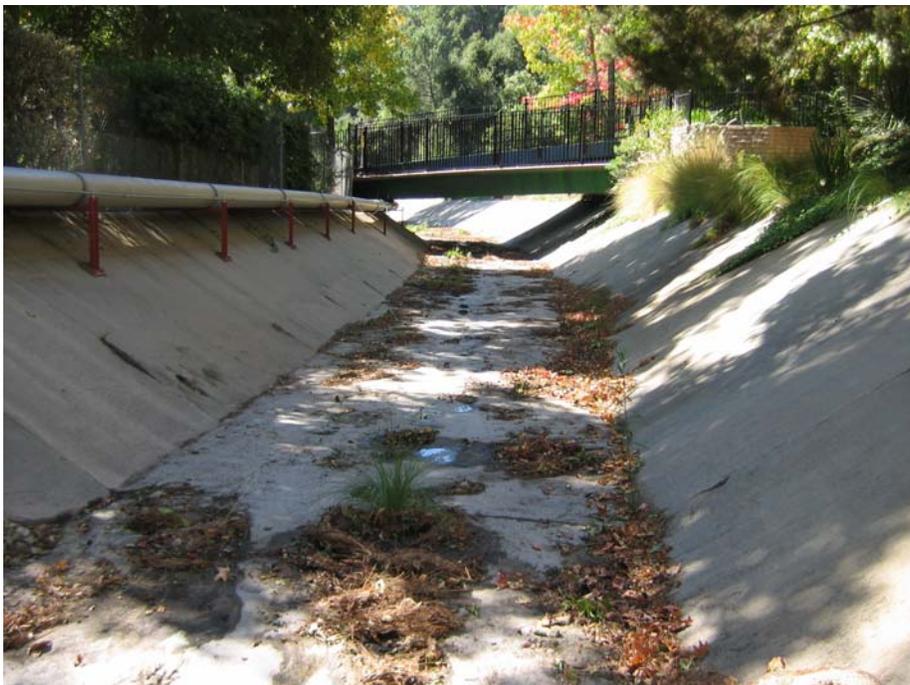
Map pt. LOP-11—Hope Garden Family Center: cement lined flood channel (Note: Channel drains to Lower Lopez Canyon).

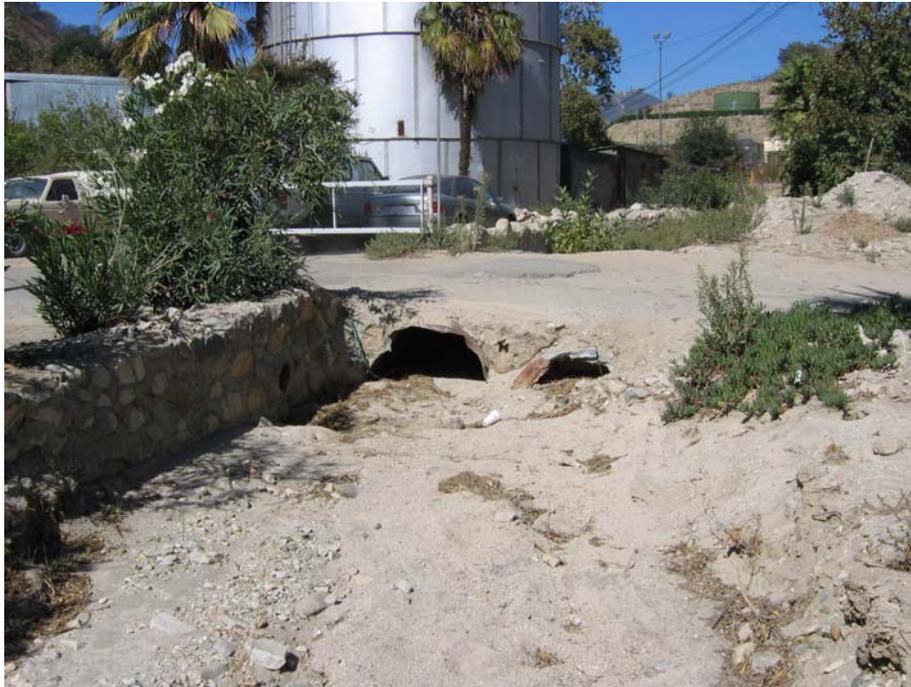
Map pt. LOP-8,9—Lower Lopez Canyon channel filled with sediment and inadequately maintained culverts.

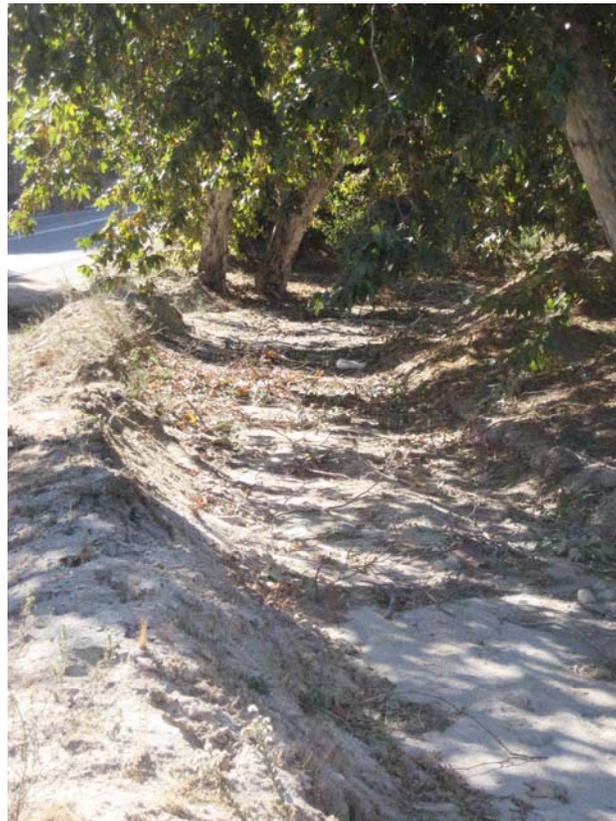
Map pt. LOP-8,9— Lower Lopez Canyon channel filled with sediment and breach in channel berm along Lopez Canyon Road.

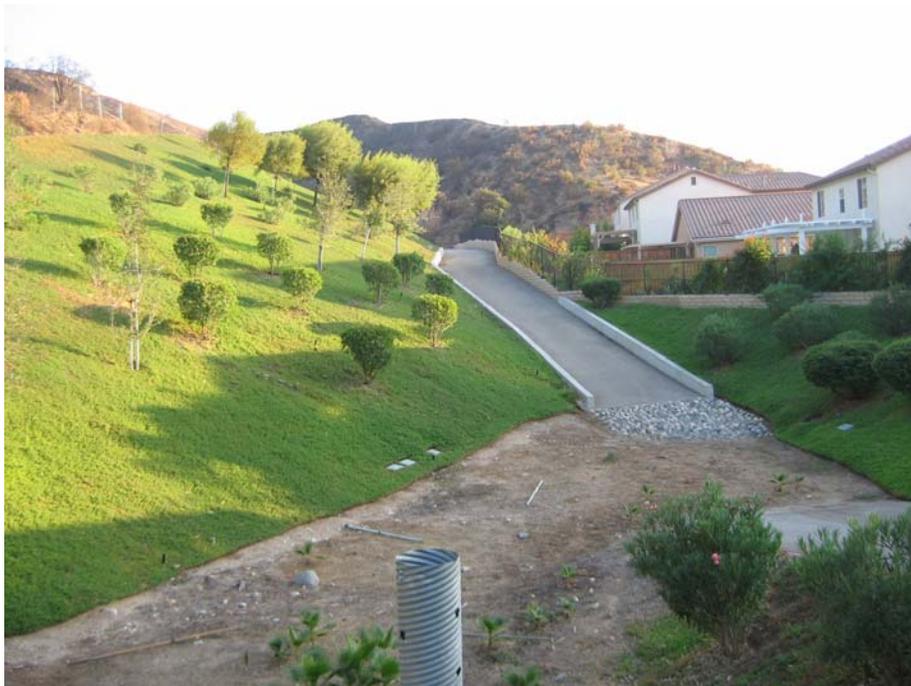
Map Pt. P-2--Mountain Glen Terrace #2 Flood Conveyance System at the east end of the subdivision.

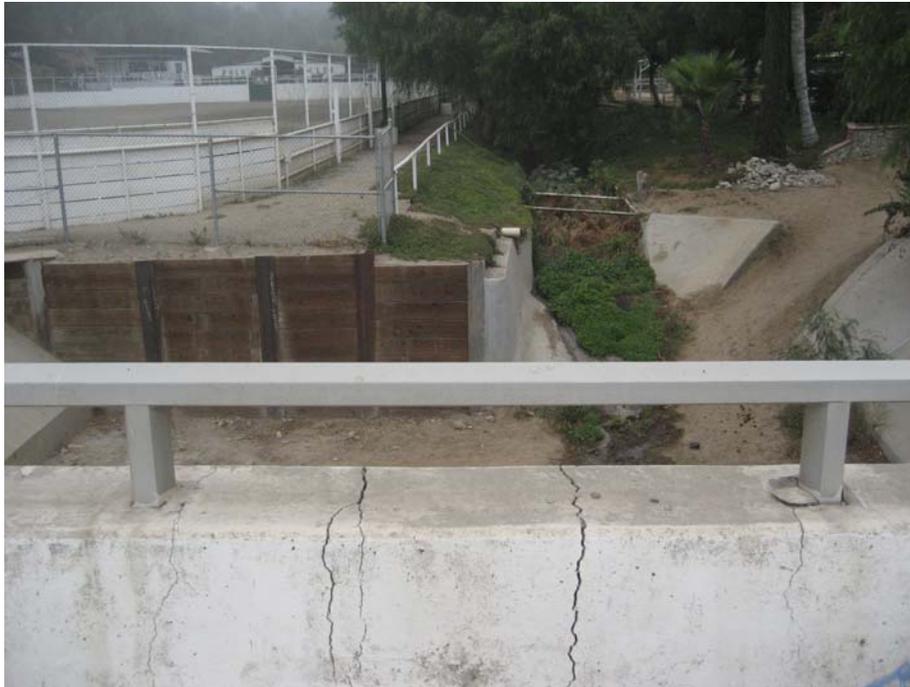
Map Pt. LT-3--Little Tujunga Bridge crossing with narrow congested channel above adjacent to Polo Club.

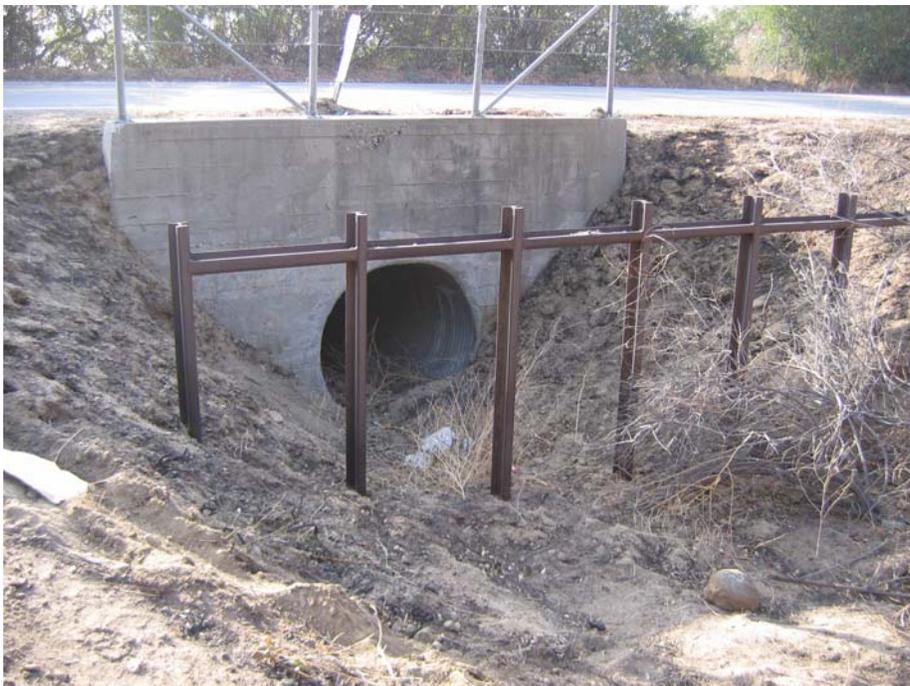
Map Pt.T-4—Representative culvert road crossing on Little Tujunga Canyon Road just below USFS District Office
Note: The trash rack may be too close to the culvert headwall and dam the entrance with debris.

- Where debris flows pose a threat of flooding, installation of trash racks should be placed upstream of road crossings in a "V" shape configuration with the apex pointing upstream to avoid causing debris buildup while still providing deflection of debris that could cause damage to the road and conveyance structure.
