Preliminary
State Emergency Assessment Team
DRAFT
Report Gap Fire
Santa Barbara County
October 9 2008

GAP FIRE COMPLEX SEAT TEAM REPORT

Executive Summary

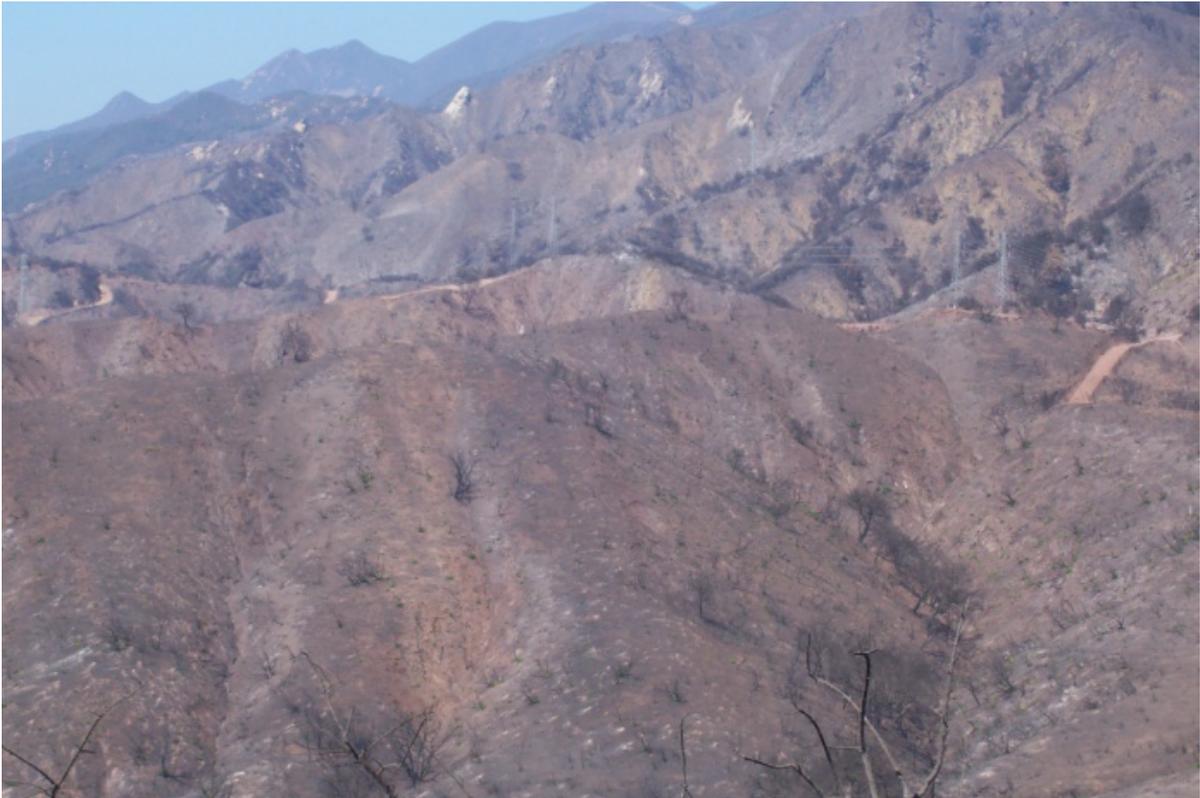
As noted by the BAER Report, “The moderate and high areas of the burn are expected to have a high hydrologic response.” This is supported by our observations of hydrophobic soils in an area identified as having burned at a moderate severity. The Burn Severity Maps show the majority of the lands (80% or more) with moderate to high burn severity. These watershed response to precipitation events is expected to be high over nearly all of the fire area due to loss of cover on steep slopes. The potential for increased flows leading to flooding and debris flows is high to very high. Runoff and sediment yield is expected to increase substantially in the first three years. Vegetation is expected to re-sprout and seed in over the majority of the burned area, with effective cover re-established within 5 years.

Burn Severity Classes (Frazier 1989) indicates that in High Severity burns hydrophobicity will repel water for over 40 seconds. Organic groundcover is less than 20%. With this in mind and the field review by the SEAT confirms that over 3/4 of the burn area is left with less than 20% ground cover and the hydrophobicity greatly exceeds 40 seconds where tested. This supports the BAER conclusion that the burn area will respond to an average storm as though it is a much larger event. Local fire and other emergency response officials were aware of these conclusions and are preparing for this winters rain with all possible caution.

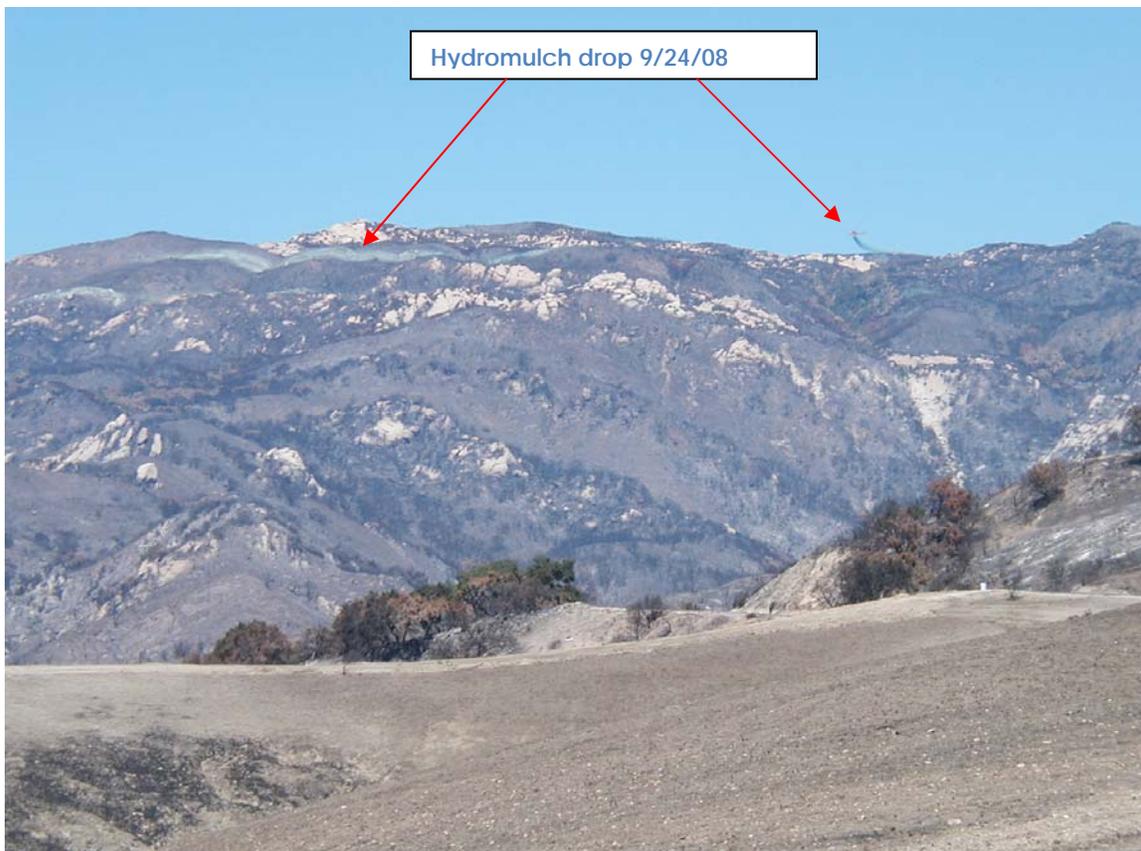
Hydromulch refers to fiber mulches and soil stabilizers that, when mixed with water and applied to the soil surface, form a matrix that helps reduce erosion and fosters plant growth. Numerous areas were identified for aerial hydromulch treatment on slopes less than 60 percent in moderate to high burn severity in the highest risk watersheds (Upper Los Carneros, Upper Glen Annie, Upper San Pedro Creek, and Upper San Jose Creek). Federal efforts are well chosen for the limited time available for covering vast areas of bare soil and limits stated to treat the debris flows effectively in the very steep mountains within the NFS lands.

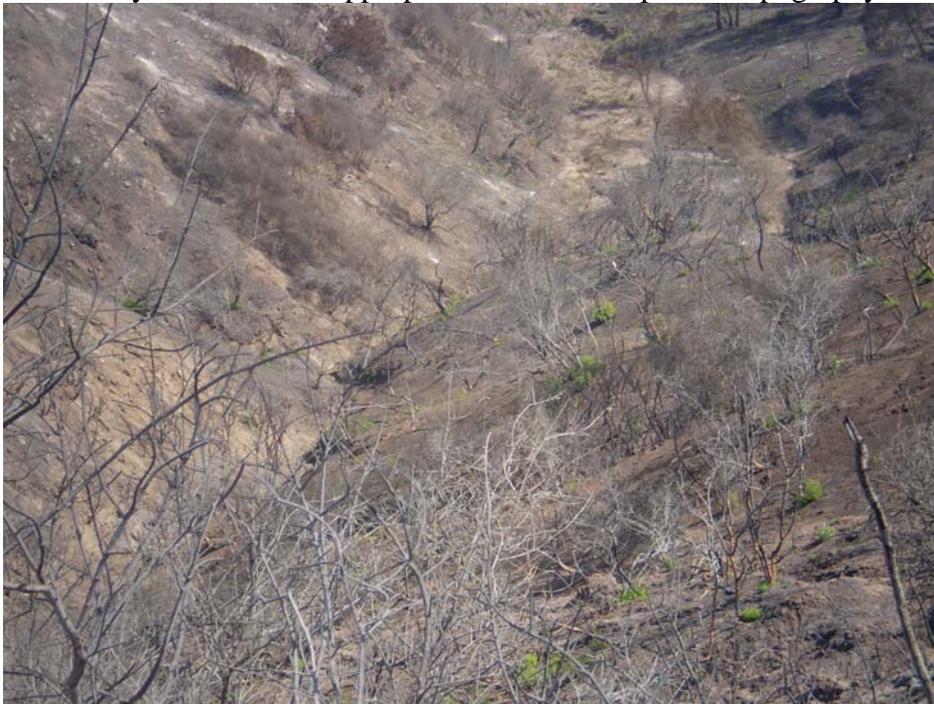
This leaves the very steep slopes that are prone to debris flows as the zones that are a large contributor of sediment that are not treated. Opportunities to reduce inputs of sediment are possible in terrain that lends itself to sediment catchment. The SEAT considers the option of sediment source control as an important option, which is a primary consideration when attempting to limit damage downstream. Many sites were noted in our field investigations that were natural valley bottoms near steep slopes prone to debris flow inputs to the system. Enhancing these features is a viable option that was recognized by the BAER Team but not employed. They felt further assessment by a licensed engineer and geologist to determine if opportunities exist for installation of debris racks or other structures at the national forest boundary should be seriously considered. Additionally, the BAER report stated “Cumulatively the greatest potential to reduce impacts to downstream values would be through implementation of a variety of treatments appropriate for the site specific topography and setting.”

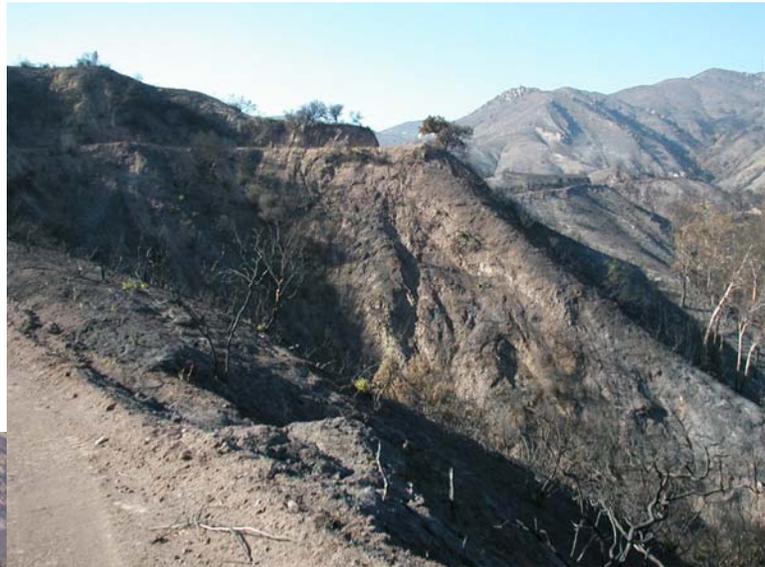
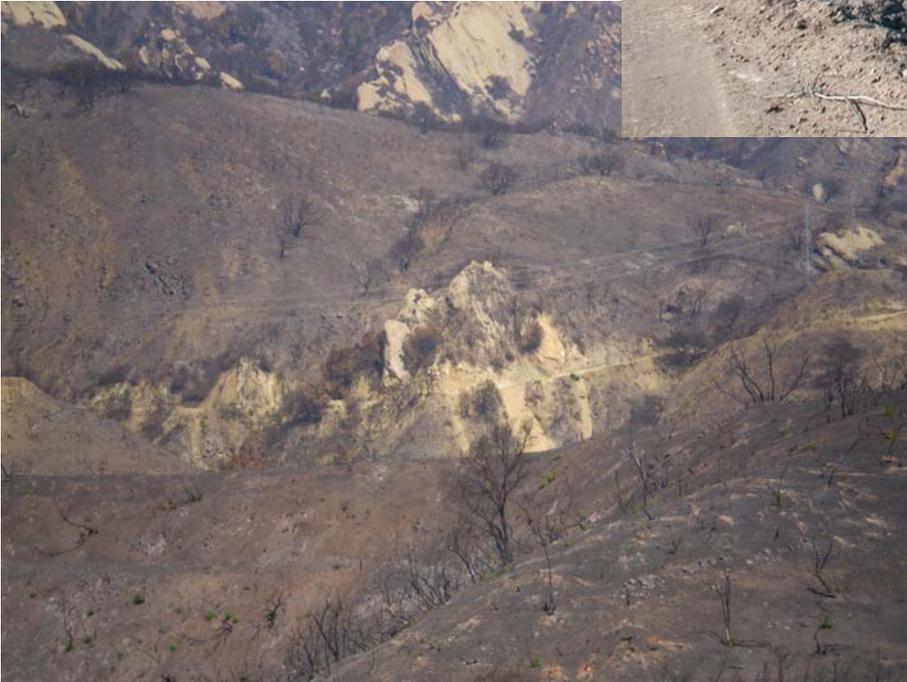
1. Southern California Edison - Randy Yenez - SEAT discussed road maintenance and Culvert inspections that will help limit loss of road prism and access during storms. Southern California Edison concerns include a high risk of failure of the access road for the powerline. This may result in partial to complete loss of the road prism in certain locations. Roads are the most likely “first impact” and a thorough inspection of all culverts and drainage facilities should be conducted immediately and throughout the winter following storm events. Loss of access to the powerline will impact the response time to address problems with the powerline which would affect all of the downstream identified communities, airport, etc.
