Marek Fire

State Emergency Assessment Team (SEAT)
Report

Affected Watersheds in Los Angeles County
California
October 30, 2008

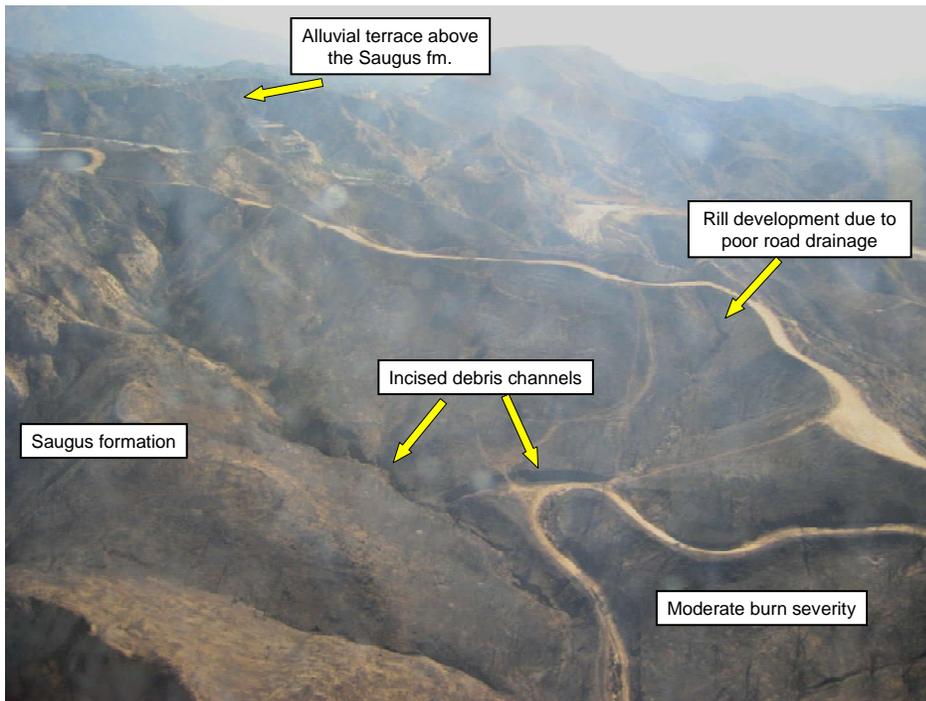
Figure 6: (below) Photograph taken during helicopter flyover.

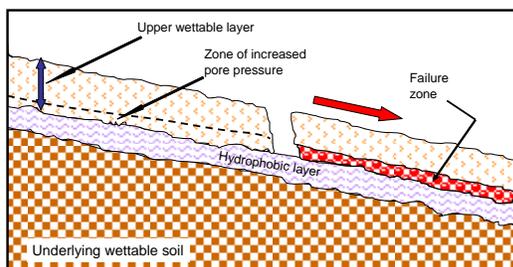
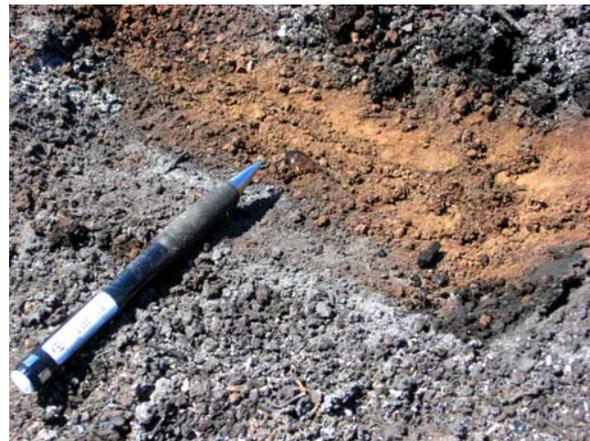
Many soils exhibit water-repellent properties after burning. On a typical burned slope, the surficial soil is loosely compacted and easily wettable (Turner and Schuster, 1996). During moderate to high burn intensities, waxy organic molecules generated by the burning of vegetative matter on and in the soil, are driven down into the soil where a hydrophobic barrier forms resisting penetration by water. During a rain event, increased pore pressure above the hydrophobic zone can cause the surface soils to slip. A steep slope is not necessary to start the process of slide movement. As momentum increases with the inclusion of pebbles, cobbles, dead vegetation, and boulders, a rapid pulse of debris flow is formed. The results can be devastating. Figures 9a and 9b provide examples of the effects of Hydrophobicity.

Figures 9a and 9b: Schematic diagram and photo of hydrophobic conditions.

Much of the materials encountered during the BAER/SEAT field evaluations appeared naturally hydrophobic in the upper 1 to 6 inches of the soil column.
